TYPE	Excavator - Small (0 - 9.9 Tonne)
MAKE	Caterpillar
MODEL	305.5E2 CR
SERIAL NUMBER	CR500583

Report Number	WILL 20220908-1032
Date	08-Sep-2022
Created By	Brett Fitzgerald
Assessor	Brett Fitzgerald
Assist. Assessor(s)	Jack Coggin
Completed By	Brett Fitzgerald
Owner	Used Equipment - Sales
Machine Hours	4621
Assessment Purpose	Sale
State	VIC

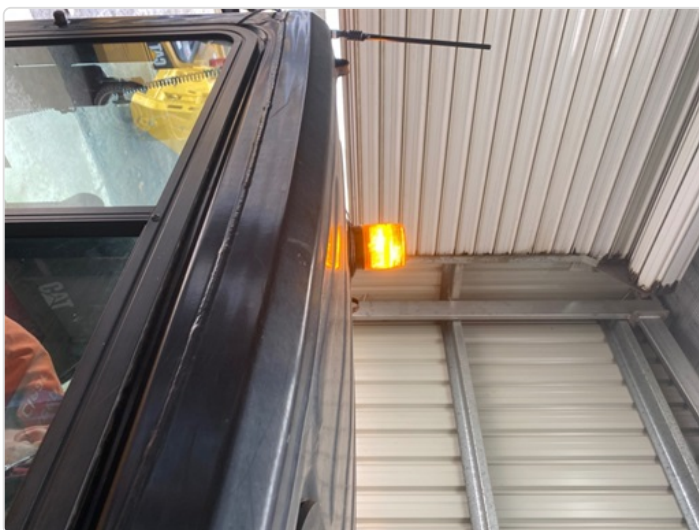
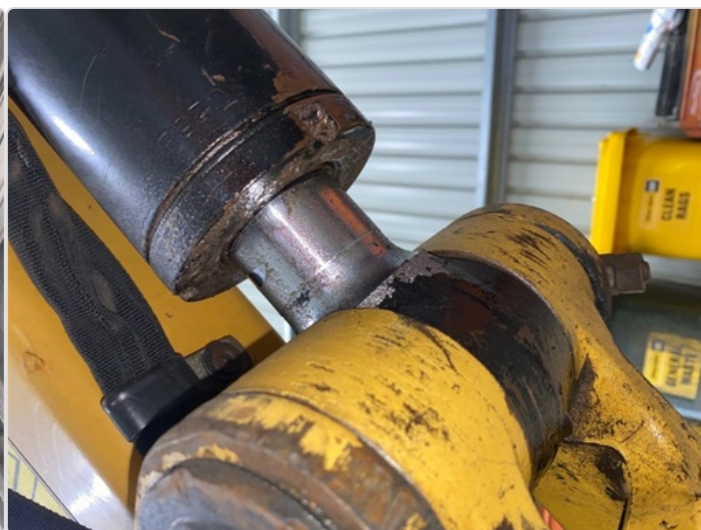
References: ISO31000						
	Assessor Comments: MINOR OIL LEAK AROUND BUCKET CYLINDER / LINKAGE AREA.

MINOR OIL LEAK @ BUCKET CYLINDER / LINKAGE AREA

OPERATIONAL MALFUNCTION	HIGH 22	LOW 2	1 Week	15-Sep-22		
	Risk Treatment Required: Major Fluid Leaks This item of plant has a major leak. Please refer to assessor comments for location and nature of leak. This leak(s) must be repaired immediately. Once repaired this unit must remain free from major leaks at all times whilst this item of plant is in operation. (this includes engine, transmission, cooling system, air, fuel, drive line, wheel hubs, steering and hydraulics).
