# ROPS stands for Roll Over Protective Structure

ROPS2 goes one step further...

ROPS2<sup>\*</sup> is an early warning and function management system designed to reduce the risk of mobile plant roll over. ROPS2 measures axial machine angles, warns the operator of pending dangerous angles and implements measures to reduce the potential of roll over.

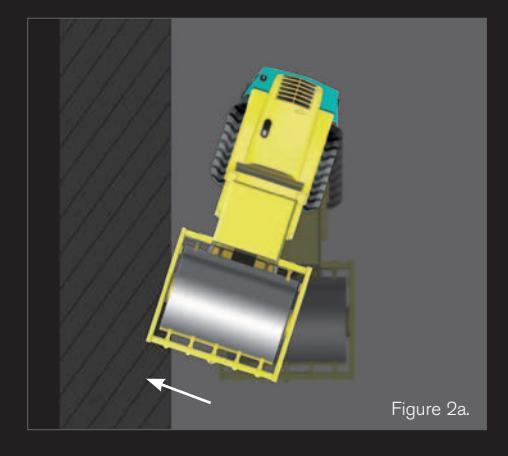
Figure 1. Axial variation between the front and rear of the roller – the drum section can move independently to the rear.

Operator perception can often be inaccurate when assessing the risk of roll over. This is particularly the case for articulated vibrating rollers that also oscillate at their articulation joints. This is because the operator station is usually fitted to the rear section and on most rollers (particularly single drum rollers) a vibrating drum is fitted to the front section.

Therefore, when working on uneven ground and cambers such as road shoulders, the operator does not always move with the front section of the unit (there is often an axial angle variation between the two sections of the roller).

This issue is particularly a problem when the machine is reversing and the operator is looking in the direction of travel because the drum will not be in his/her field of vision. In this case ROPS2 fitted to the front section would warn the operator of a potentially dangerous angle.

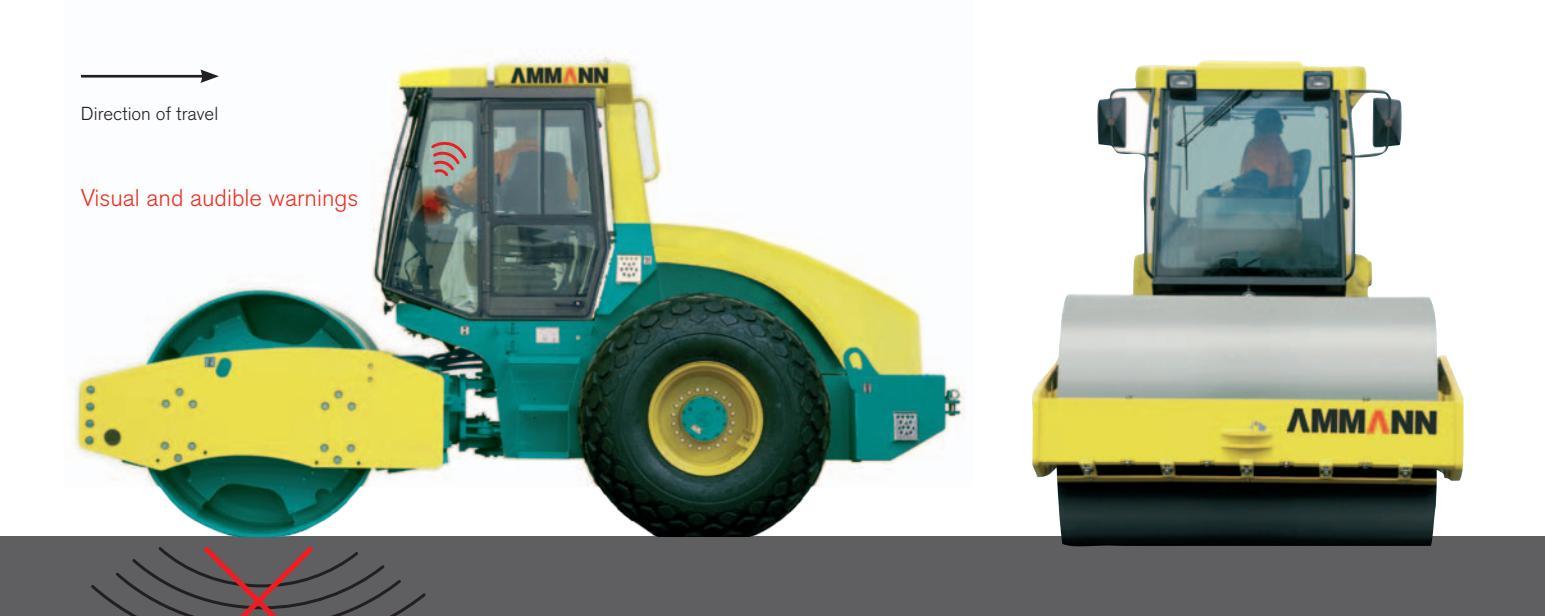
Figure 3.

Vibration lock-out improves machine control when reversing out of these situations.

ROPS2 locks-out vibration and continues to warn the operator of roll over danger.

Stage 2 of ROPS2 locks-out the vibration function reducing the potential of rollover by:

- reducing drum drift/slide by maximising frictional contact of the drum with the ground (vibration reduces frictional contact).
- reducing the possibility of edge collapse under the force of vibration. This also ensures that if an edge is collapsing (eg road shoulder) the vibration does not accelerate the process. Vibration imparts force on the ground that can cause edge collapse.
- greater operator control.

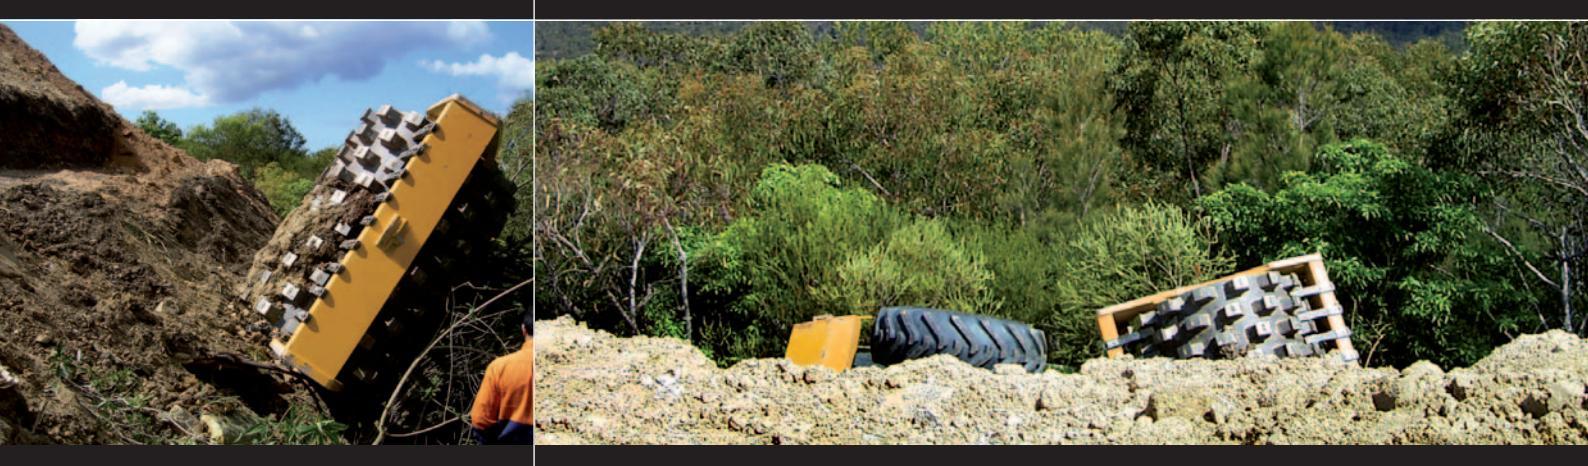
This machine was not fitted with ROPS2
